## New York Harbor Buoy Recovery

by LT Amy Florentino, USCGC KATHERINE WALKER (WLM 552)

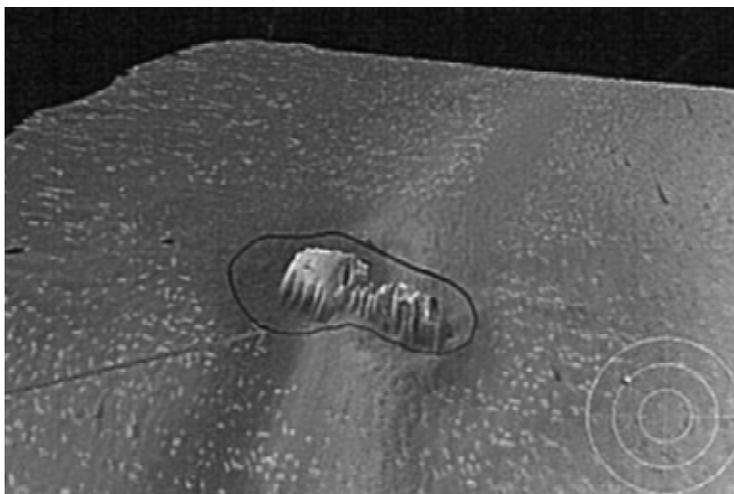
*Sonar image of sunken hull after bottom survey.*

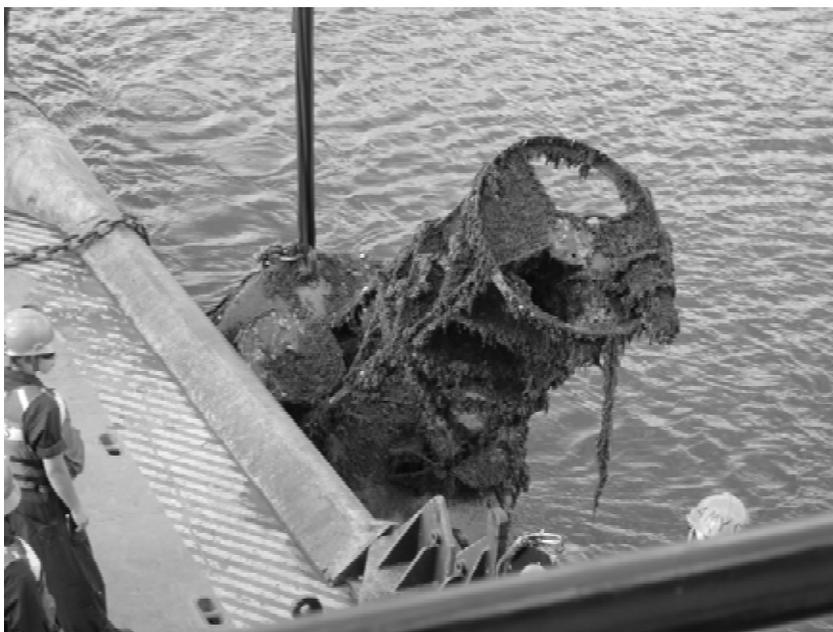
With the recovery mooring set up and lowered to the exact location of the sunken hull, the dive team went back to work. Despite zero visibility, the divers were able to affix the chain to the buoy immediately after reaching the bottom. After affixing the recovery mooring, KATHERINE WALKER began to retrieve the sunken hull. Not knowing exactly what was attached to the buoy, the buoy deck supervisor carefully raised the load and monitored the weight on the crane. Before we knew it, a hull popped up to the surface. The hull had obviously been hit by a vessel, was holed, partially flooded and needed to be dewatered prior to coming on board. Despite the damage to the hull and its age, it was in good enough condition to be returned to the buoy depot for refurbishing.

*First sight of daylight in several years. Despite heavy growth and a hole that caused it to initially sink, the hull was in good shape and even the light was intact.*
