## New York Harbor Buoy Recovery

by LT Amy Florentino, USCGC KATHERINE WALKER (WLM 552)

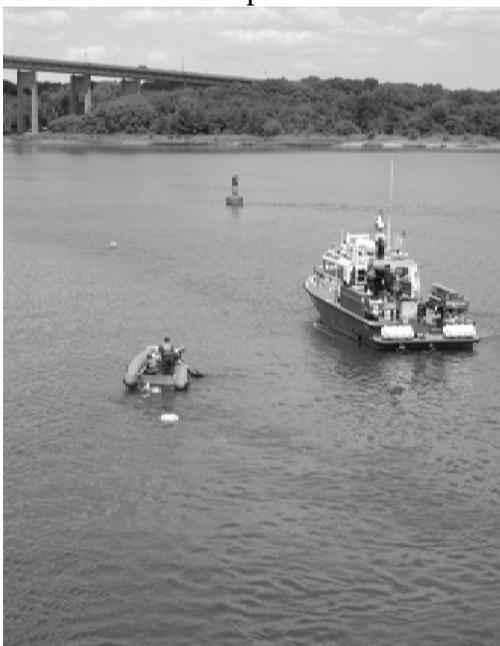
*Once in the water, KW's small boat assists a diver to the marker. Divers were deployed from the decks of the Jersey City Fire Boat, which was better suited for dive ops.*
